Lake Worth Lagoon Initiative

Habitat Group Update

September 9, 2009

Beth Orlando
Coastal Ecosystems Section
Applied Science Bureau

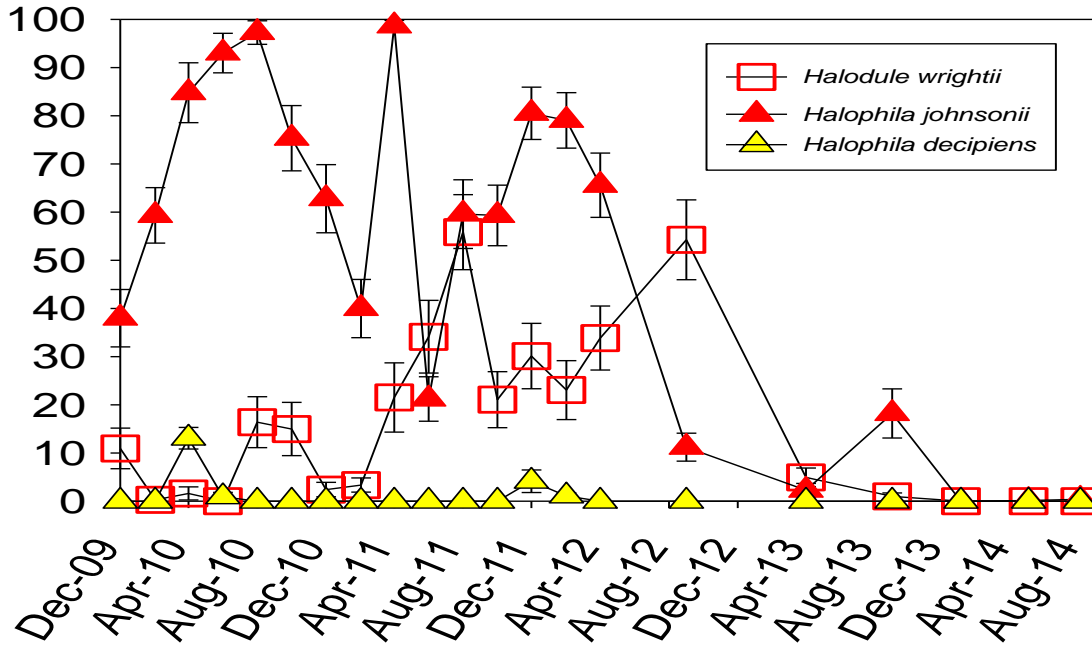
C-51C

Percent Occurrence SAV

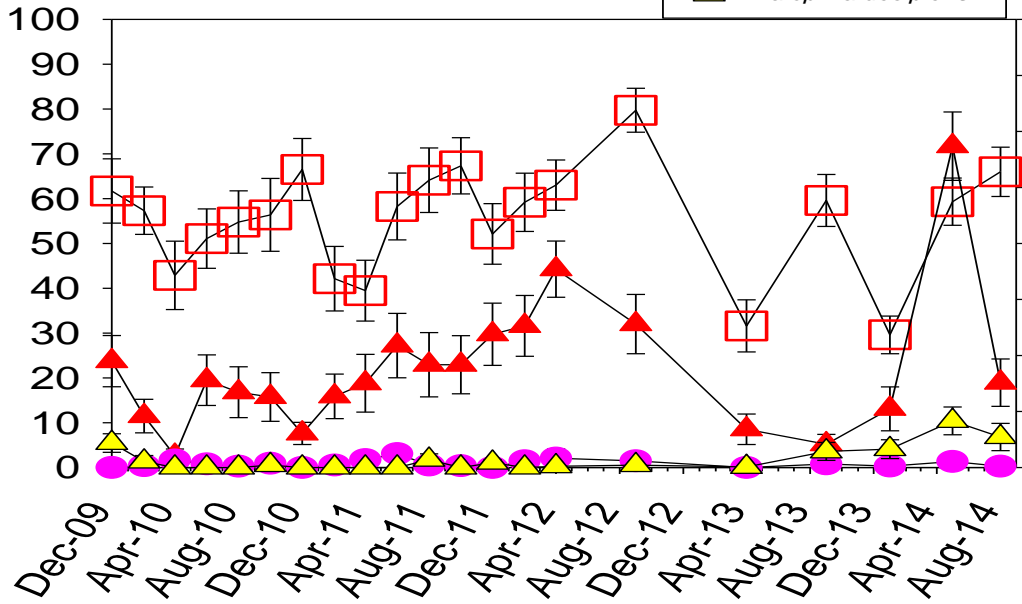
C-17B

- Canopy Height
Halodule wrightii
- ▲ *Halophila johnsonii*
- *Thalassia testudinum*
- ▲ *Halophila decipiens*

Percent Occurrence SAV

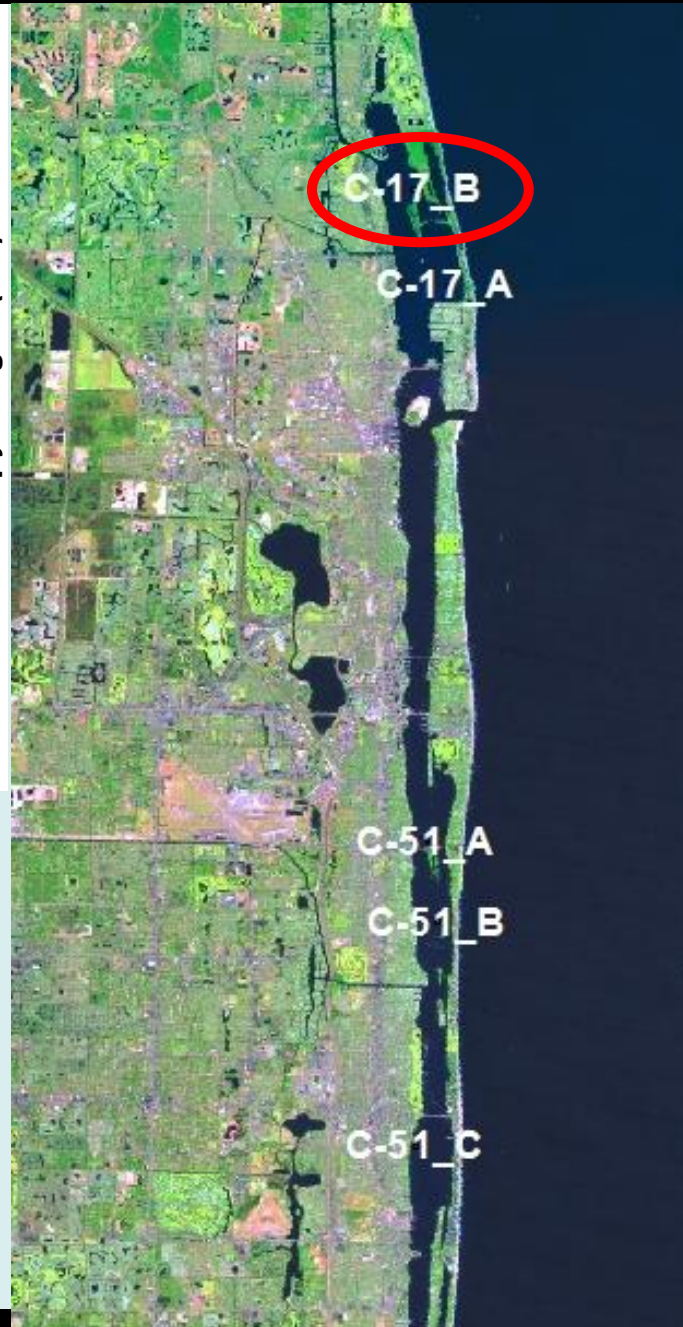
C-17A

- *Halodule wrightii*
- *Syringodium filiforme*
- ▲ *Halophila johnsonii*
- *Thalassia testudinum*
- ▲ *Halophila decipiens*
- Canopy Height
